WT-1328

Operation

REDWING

May 1956

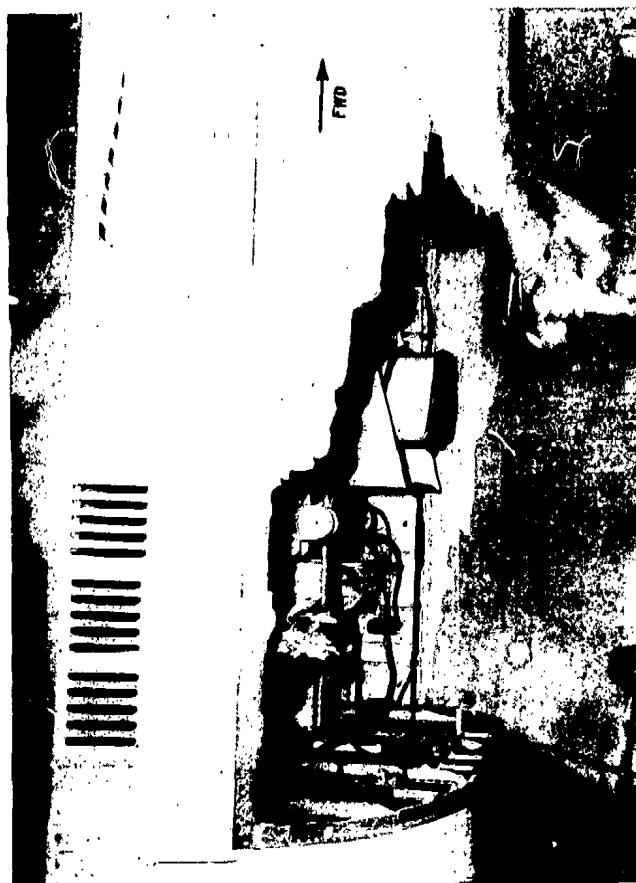
Figure 3.7 Damage photo, ECM radome, Shot Huron.

The ECM radome and bomb-bay doors were unshored for this shot as they were for Shot Tewa. The radome suffered a complete failure as a result of the overpressure (Figure 3.7). The forward panel of the lower aft left-hand bomb-bay door was buckled over approximately a two-foot length. There was visual evidence of damage to one door rib and probable damage to a second rib in this location. Also, slight permanent skin buckles occurred on the lower-left-forward door adjacent to the hinge support (Figure 3.6). No other damage was noted.

4. It is recommended that revisions be made to the ECM radome to increase its overpressure capability to be consistent with the basic overpressure capability of the B-52.
